Appendix A

Plan Sheets and Typical Cross-Section Drawing of Project Components

COASTAL STORM RISK MANAGEMENT FEASIBILITY STUDY FOR THE SOUTH SHORE OF STATEN ISLAND

PHASE 1 FORT WADSWORTH TO OAKWOOD BEACH

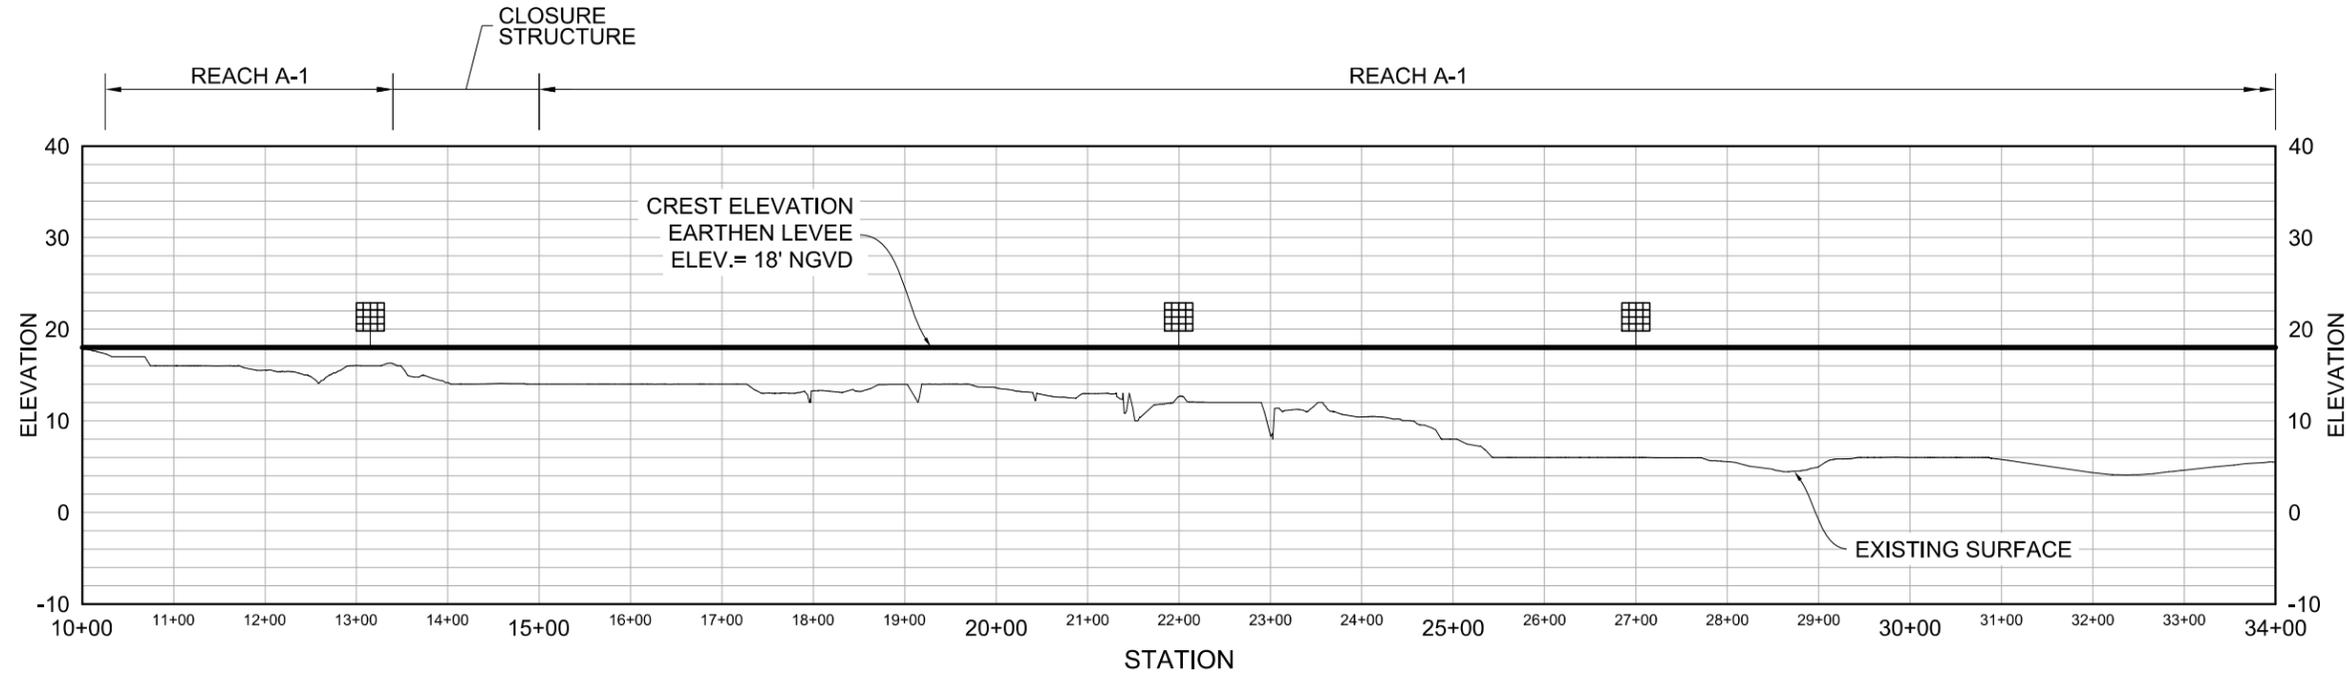
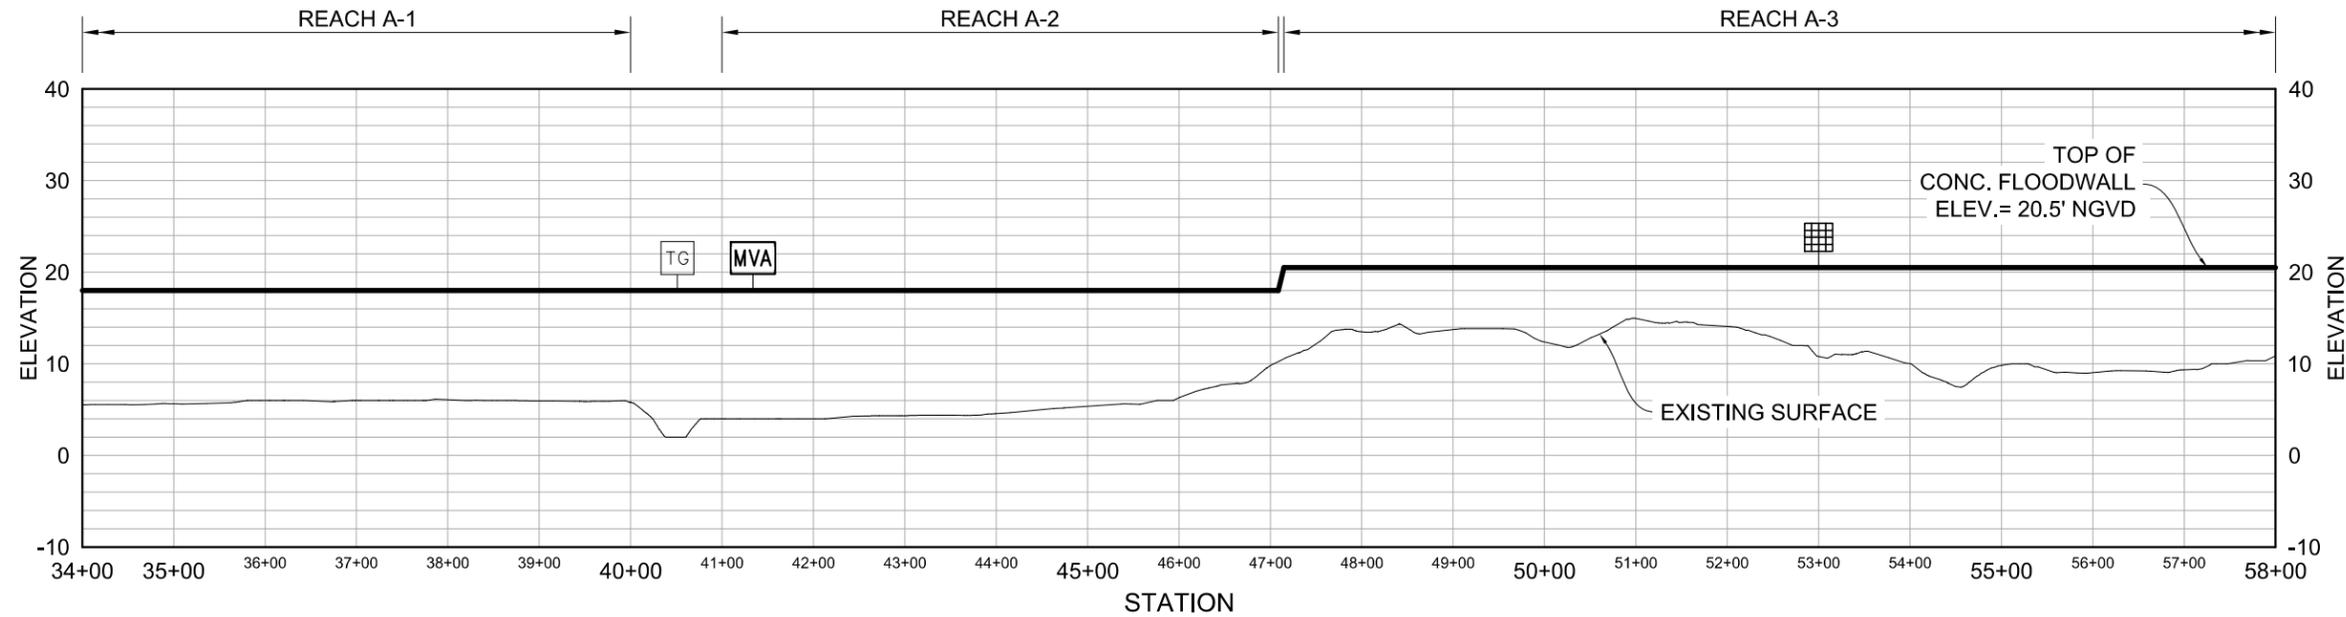
1. TYPICAL SECTIONS SHOWN ON C-501 TO C-507.
2. ALL ELEVATIONS REFERENCED TO NGVD 29.
3. PROFILES FOR 15.6 FT SWL CALCULATED ALONG BASELINE. REFER TO SITE PLANS FOR BASELINE LOCATION.
4. CLOSURE STRUCTURE ON SHEETS C-515 & C-516.

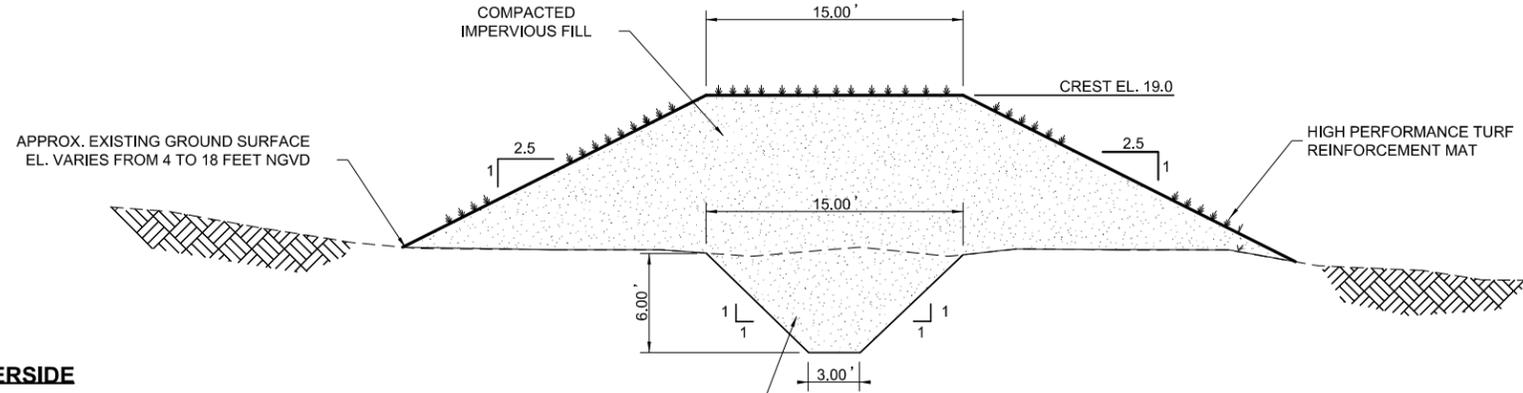
D4 LEVEE SECTION (16.6 FT SWL)
C-502 SCALE: 3/16"=1'-0"

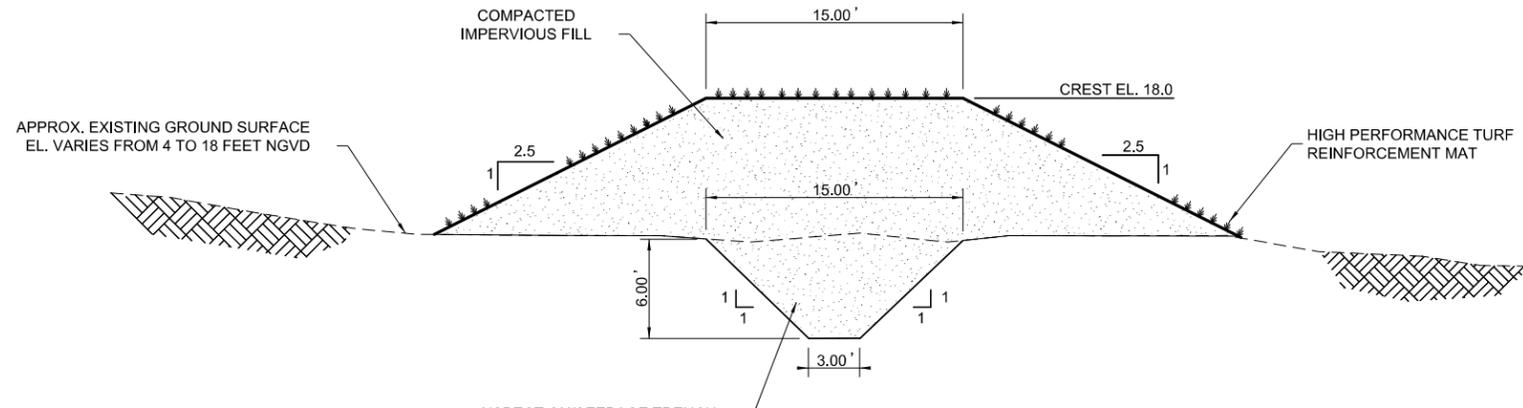
C2 LEVEE SECTION (15.6 FT SWL)
C-502 SCALE: 3/16"=1'-0"

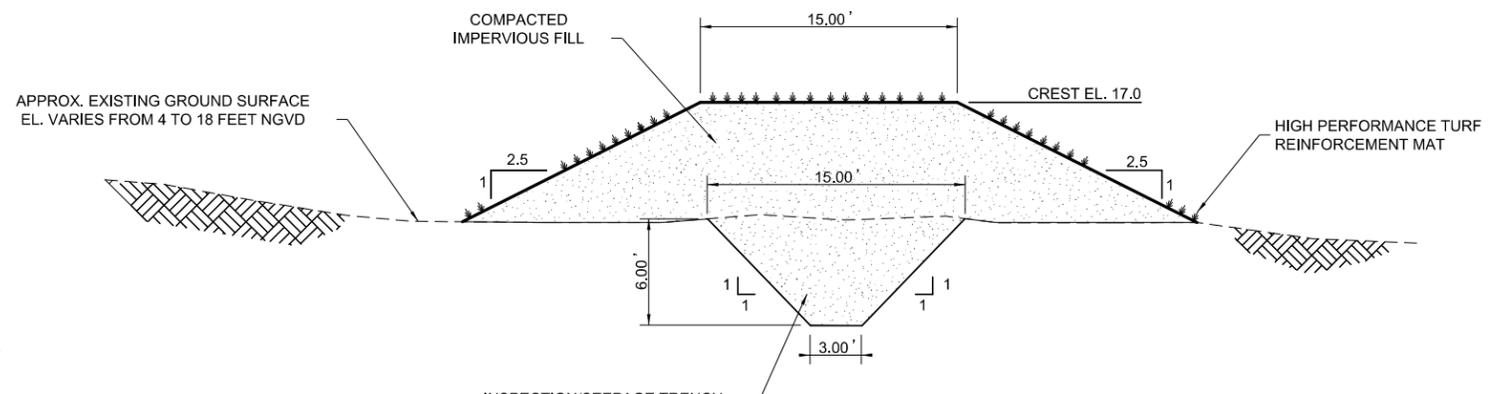
B4 LEVEE SECTION (14.3 FT SWL)
C-502 SCALE: 3/16"=1'-0"

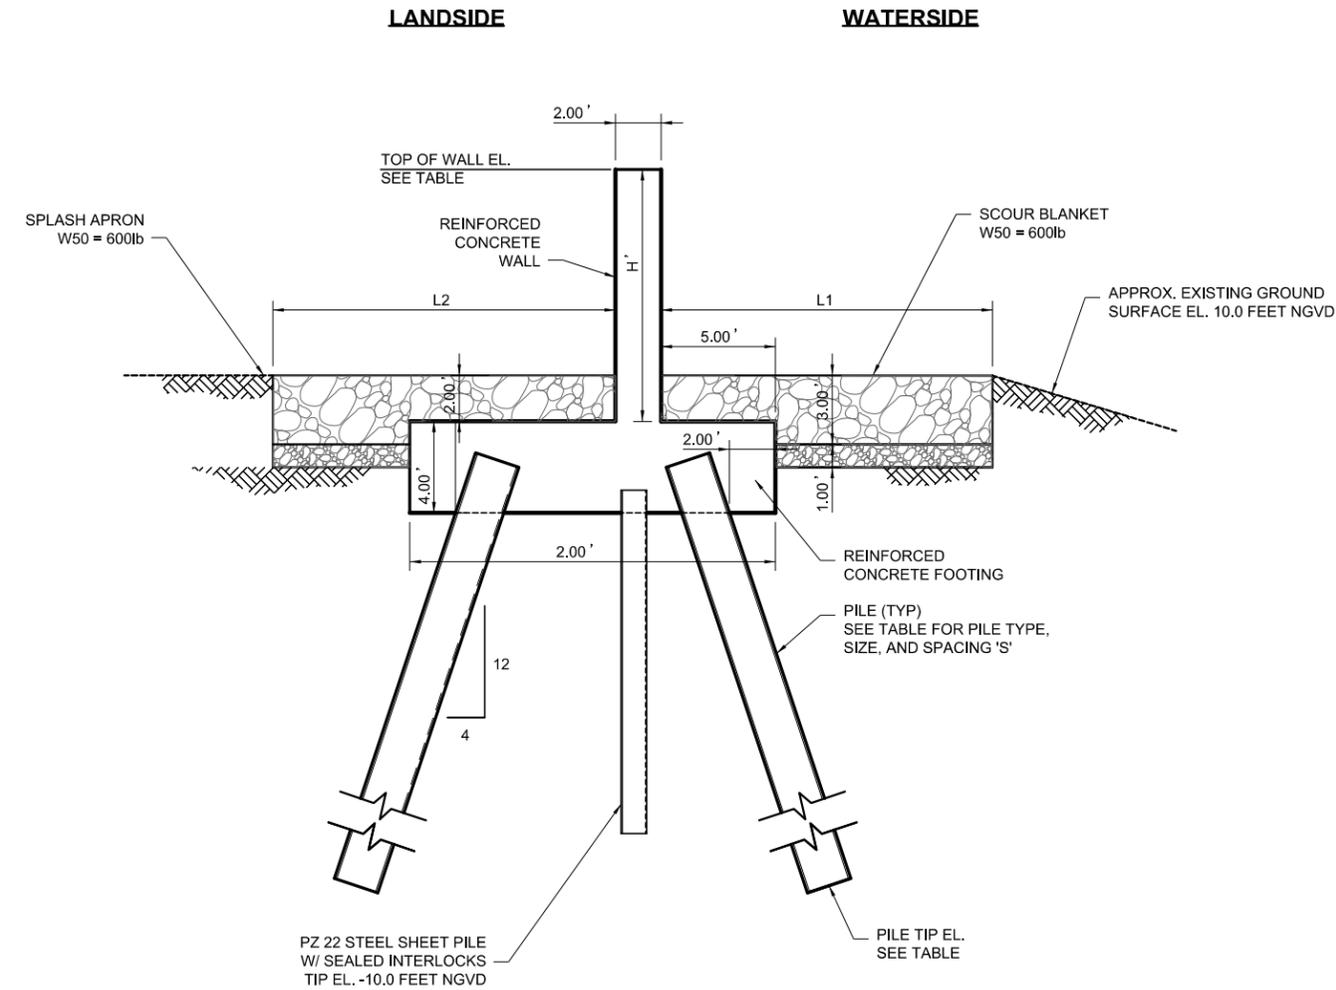
B2 FLOOD WALL SECTION
SCALE: 1/4"=1'-0"

SWL (FT)	ELEVATIONS (FT, NGVD)		PILE DATA		DIMENSIONS					
	TOP OF WALL	PILE TIP	TYPE	SIZE	H (FT)	B (FT)	T (FT)	L1 (FT)	L2 (FT)	S (FT)
13.3	16.0	-75.0	H-PILE	HP14 X 89	8.0	12.0	1.5	15.0	10.0	12.0
14.3	18.0	-75.0	H-PILE	HP14 X 89	10.0	15.0	1.5	15.0	12.0	11.0
15.6	20.5	-90.0	H-PILE	HP14 X 89	12.5	16.0	2.0	15.0	15.0	12.0
16.6	22.5	-90.0	H-PILE	HP14 X 90	14.5	18.0	2.5	15.0	16.0	10.0

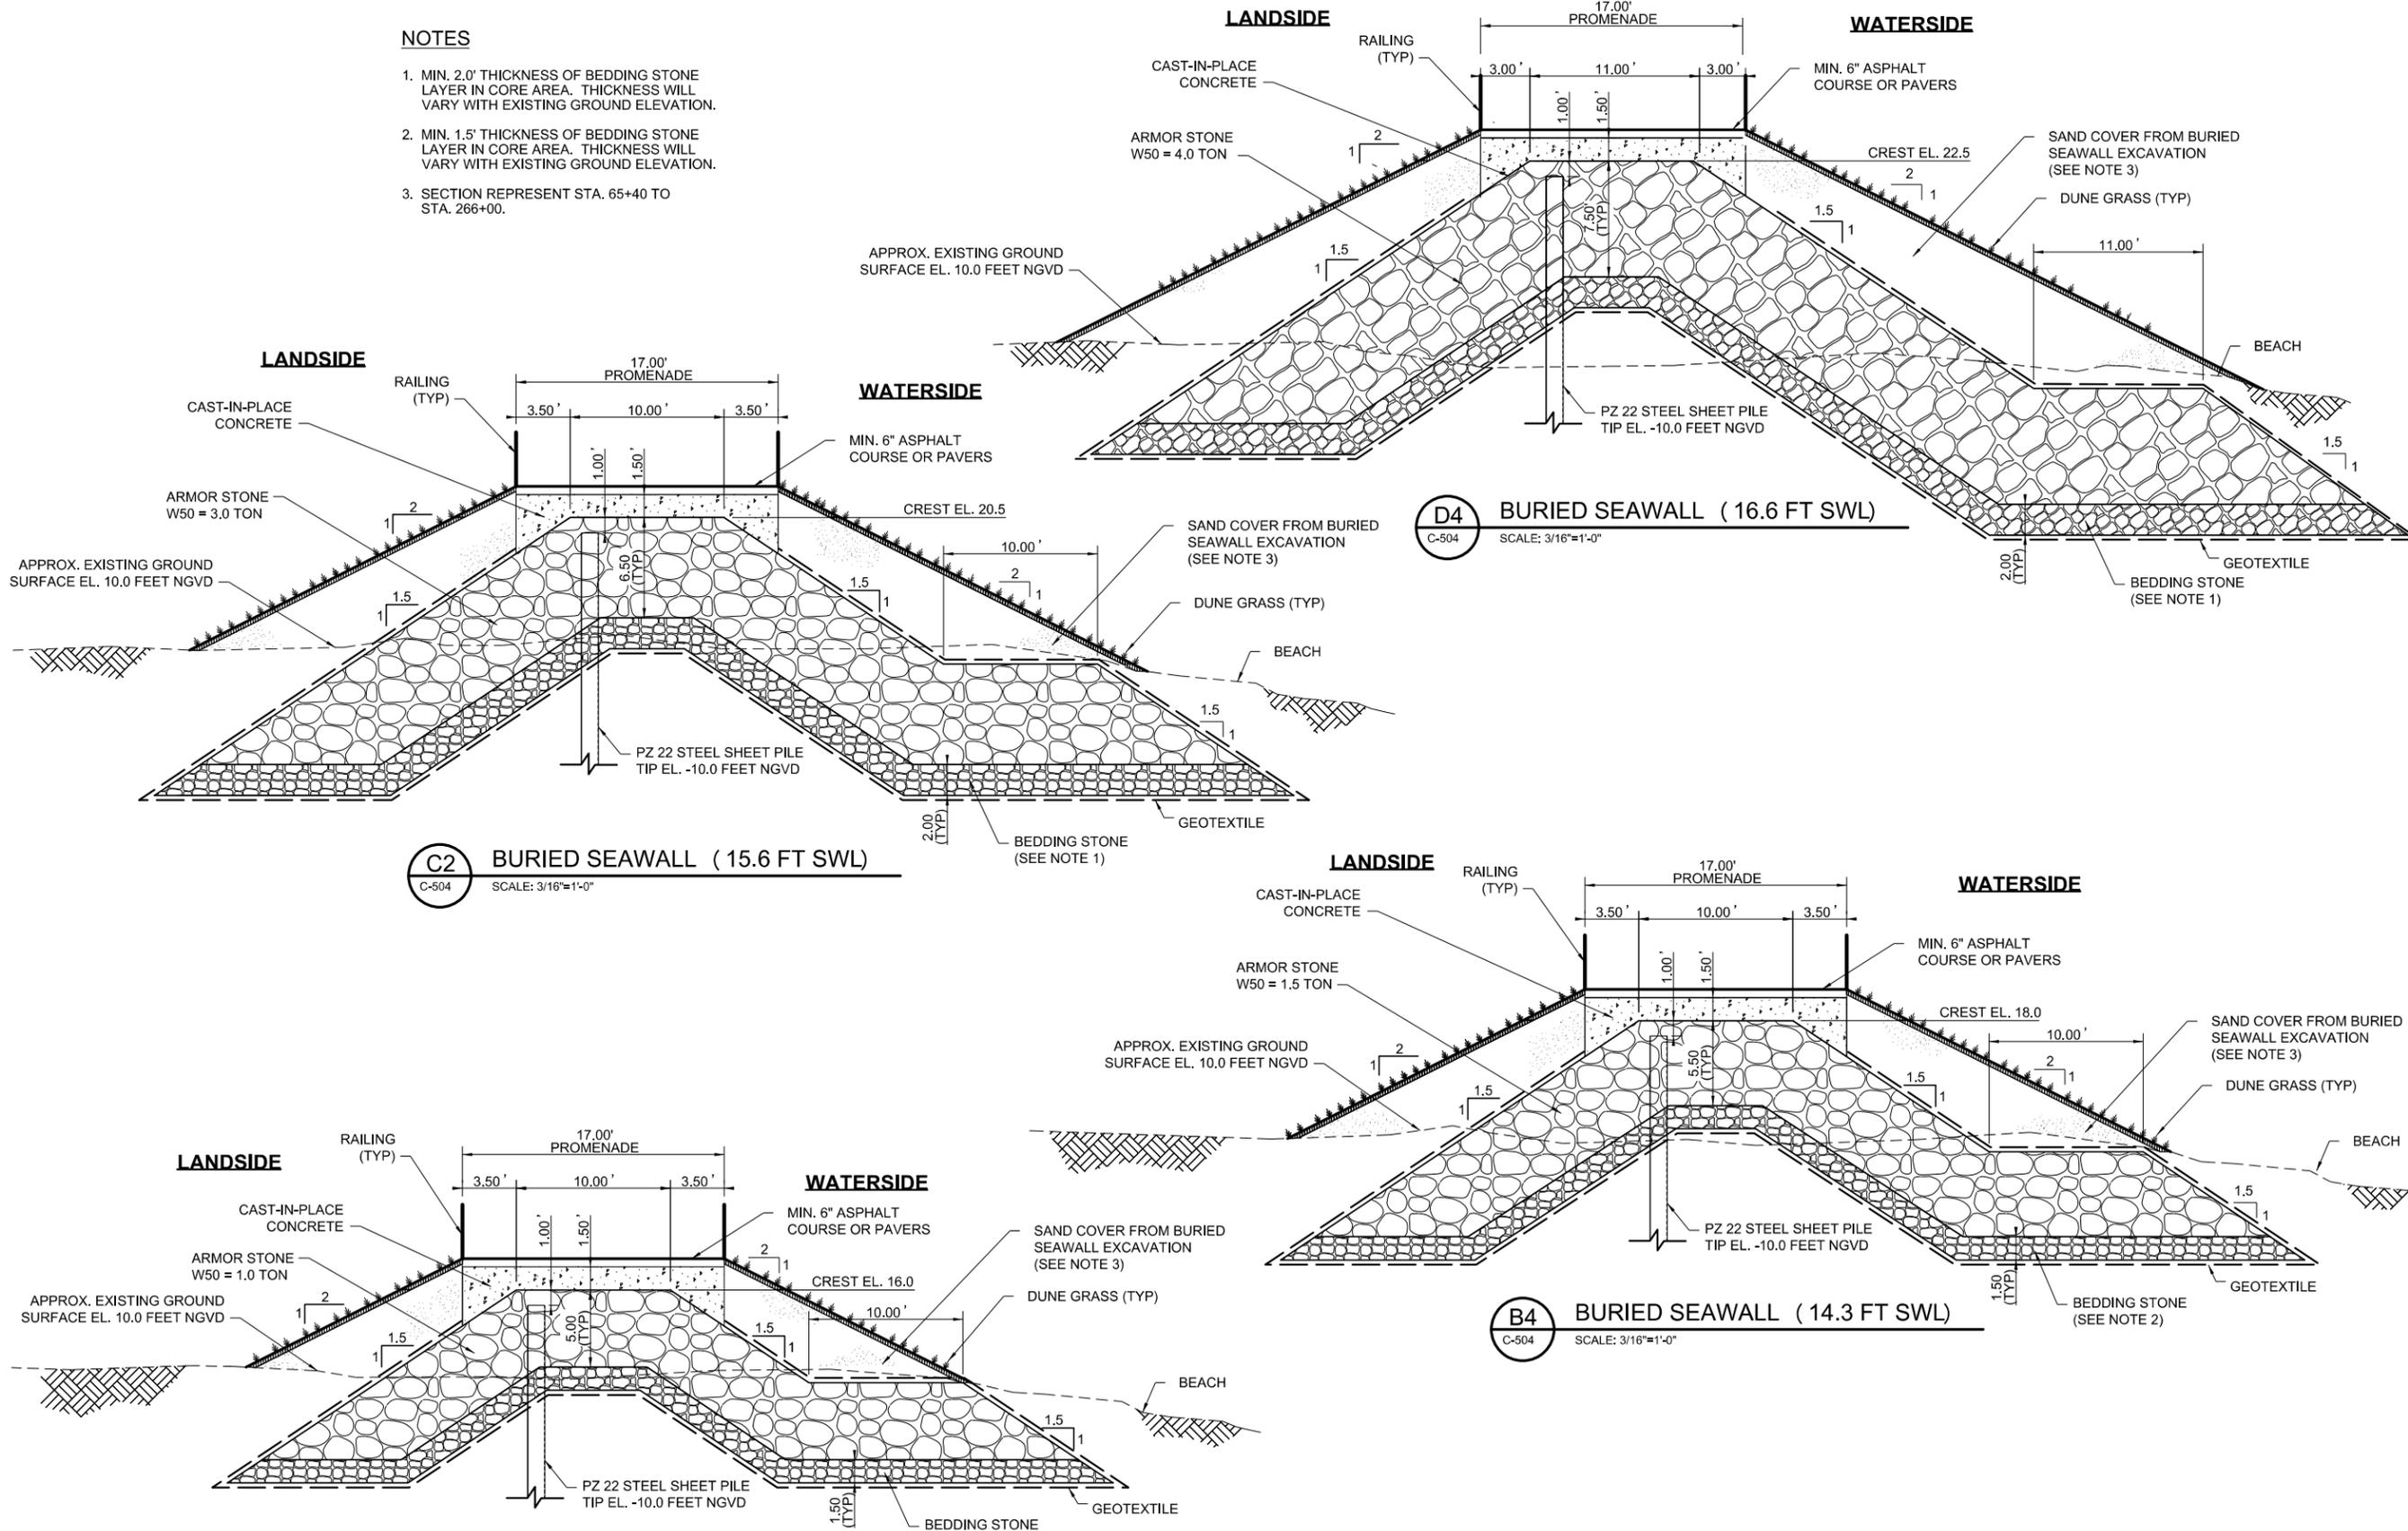
1. MIN. 2.0' THICKNESS OF BEDDING STONE LAYER IN CORE AREA. THICKNESS WILL VARY WITH EXISTING GROUND ELEVATION.
2. MIN. 1.5' THICKNESS OF BEDDING STONE LAYER IN CORE AREA. THICKNESS WILL VARY WITH EXISTING GROUND ELEVATION.
3. SECTION REPRESENT STA. 65+40 TO STA. 266+00.

A2 BURIED SEAWALL (13.3 FT SWL)
C-504 SCALE: 3/16"=1'-0"

C2 BURIED SEAWALL (15.6 FT SWL)
C-504 SCALE: 3/16"=1'-0"

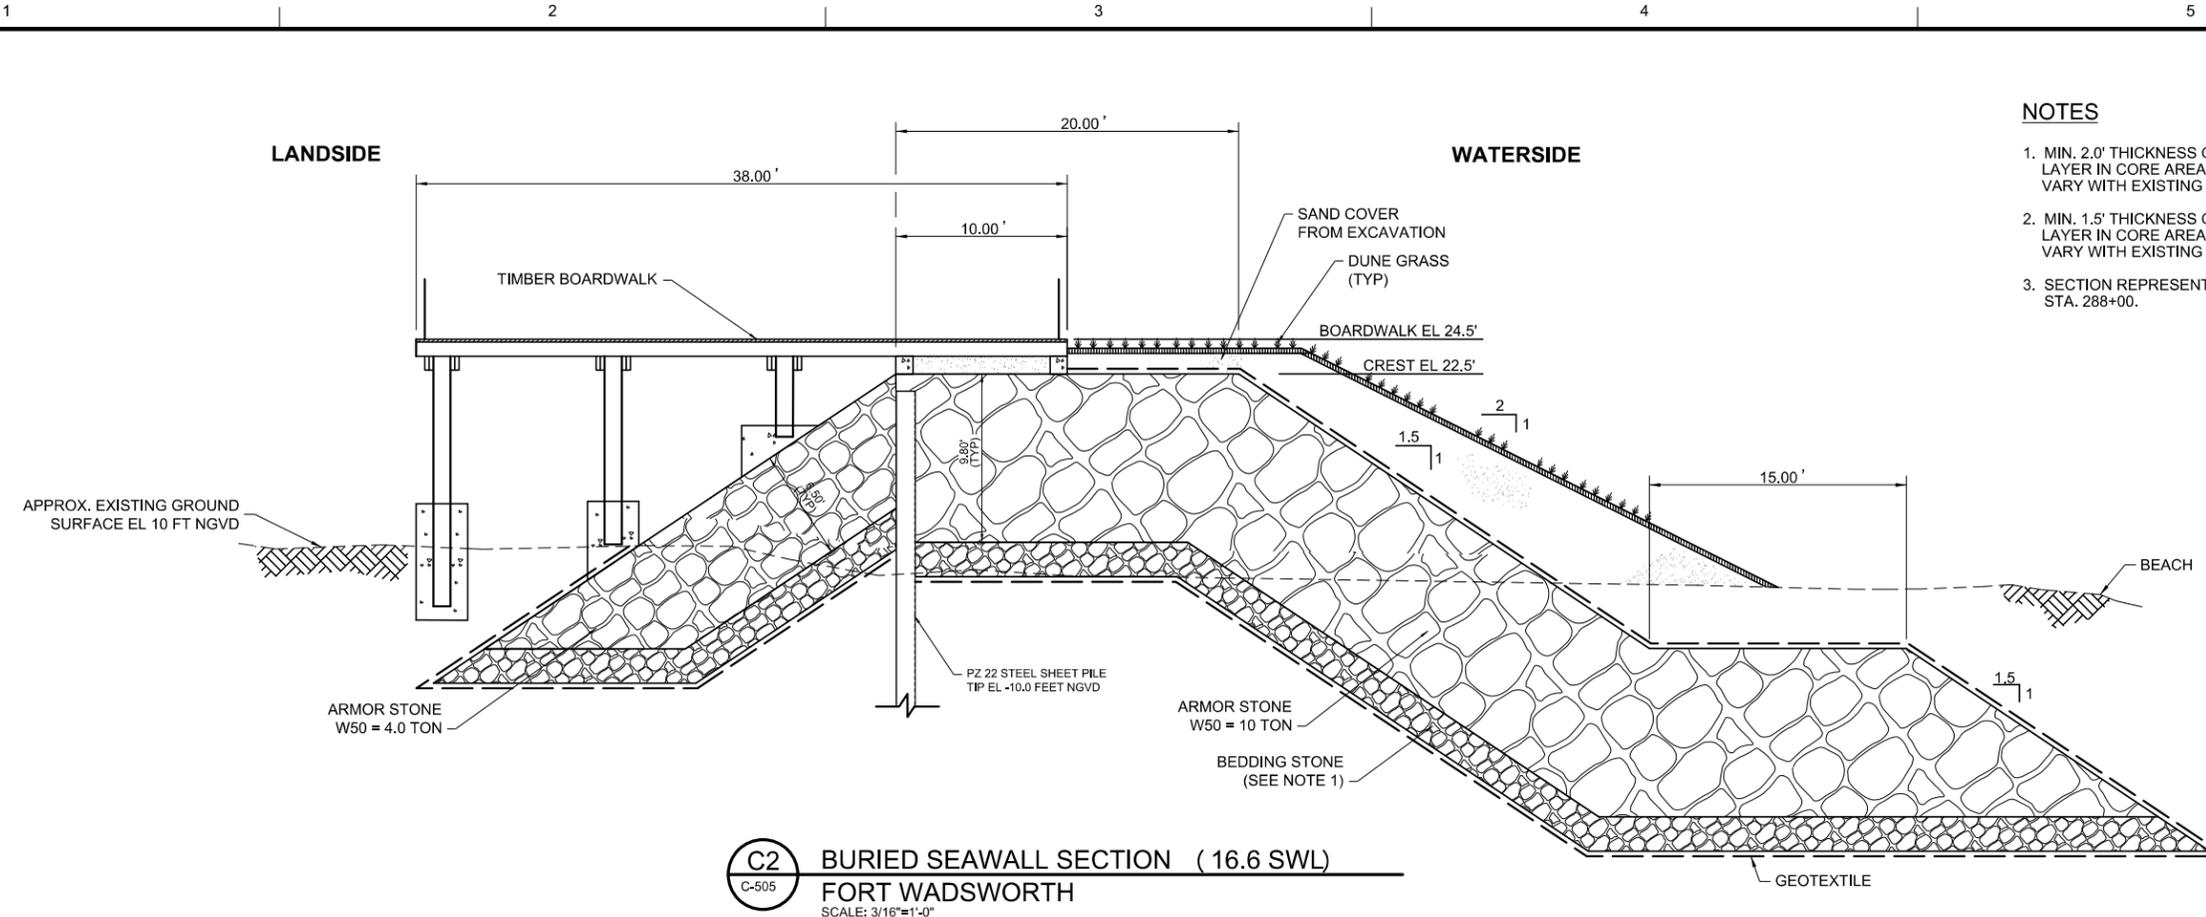
C2 BURIED SEAWALL SECTION (16.6 SWL)
 FORT WADSWORTH
 SCALE: 3/16"=1'-0"

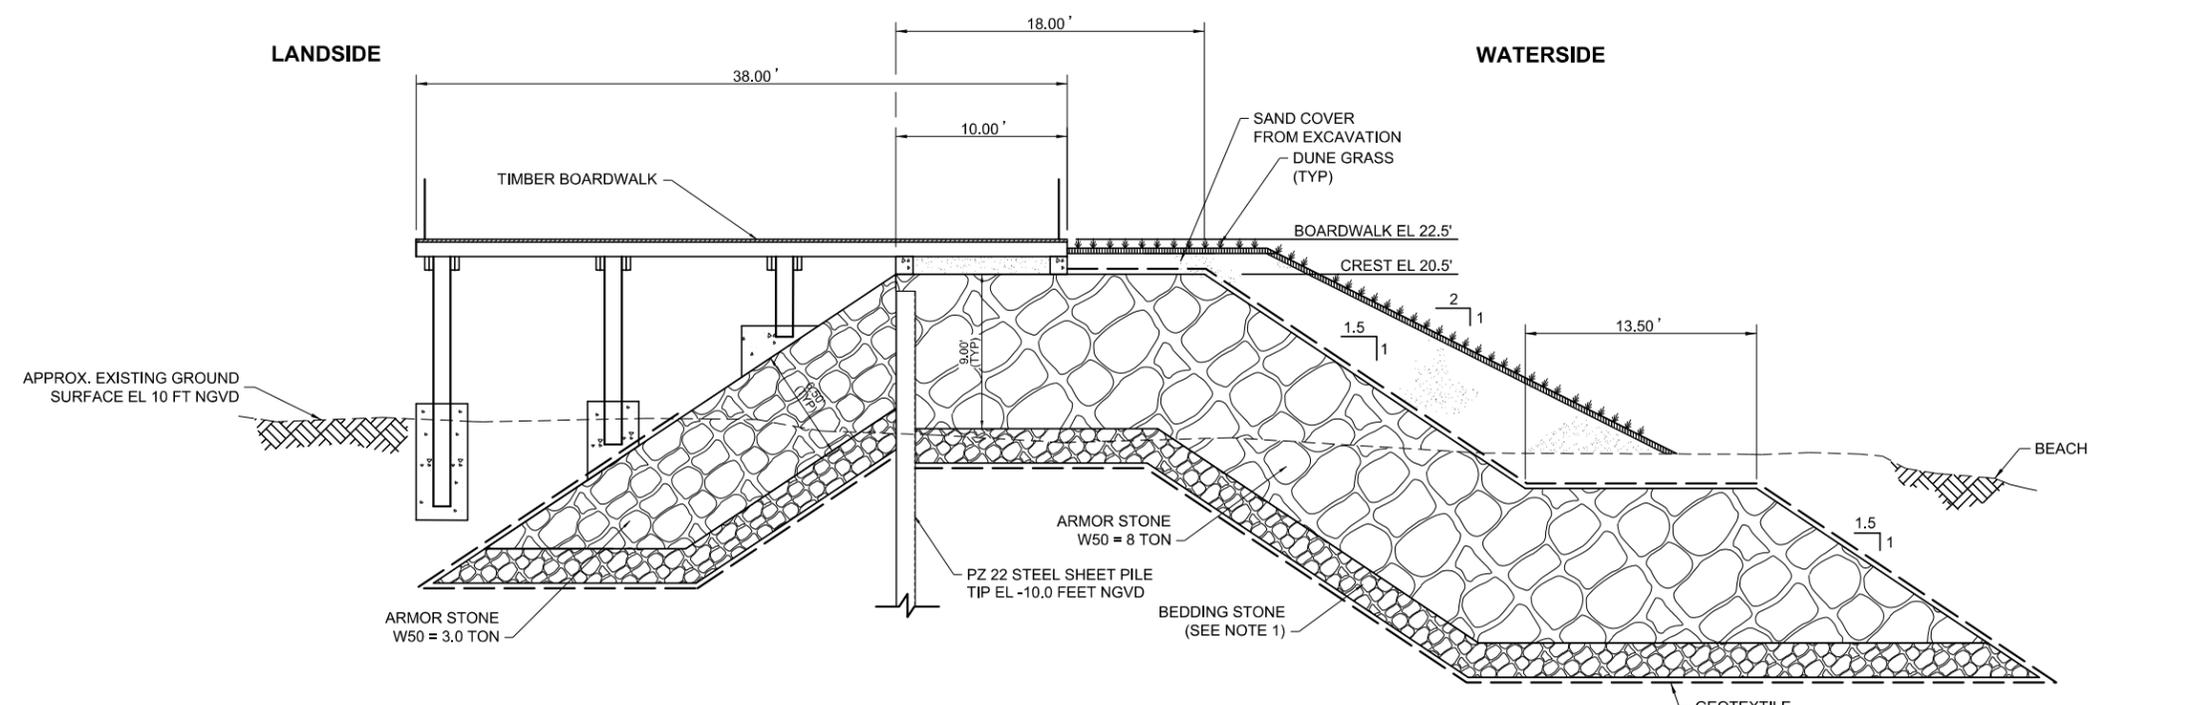
A2 BURIED SEAWALL SECTION (15.6 SWL)
 FORT WADSWORTH
 SCALE: 3/16"=1'-0"

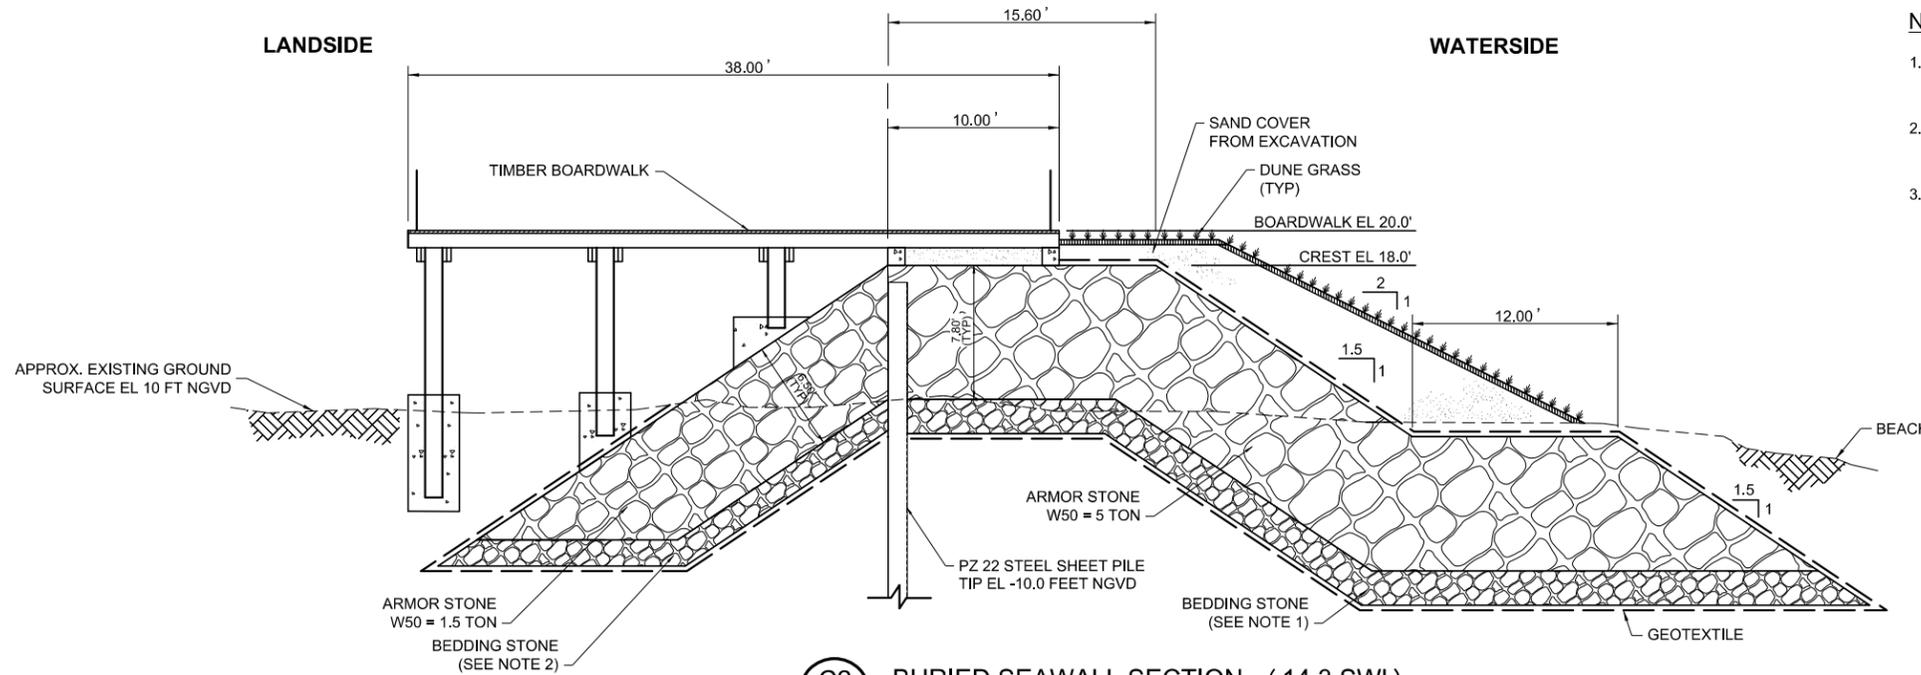
C2 BURIED SEAWALL SECTION (14.3 SWL)
 FORT WADSWORTH
 SCALE: 3/16"=1'-0"

- NOTES**
1. MIN. 2.0' THICKNESS OF BEDDING STONE LAYER IN CORE AREA. THICKNESS WILL VARY WITH EXISTING GROUND ELEVATION.
 2. MIN. 1.5' THICKNESS OF BEDDING STONE LAYER IN CORE AREA. THICKNESS WILL VARY WITH EXISTING GROUND ELEVATION.
 3. SECTION REPRESENT STA. 266+00 TO STA. 288+00.

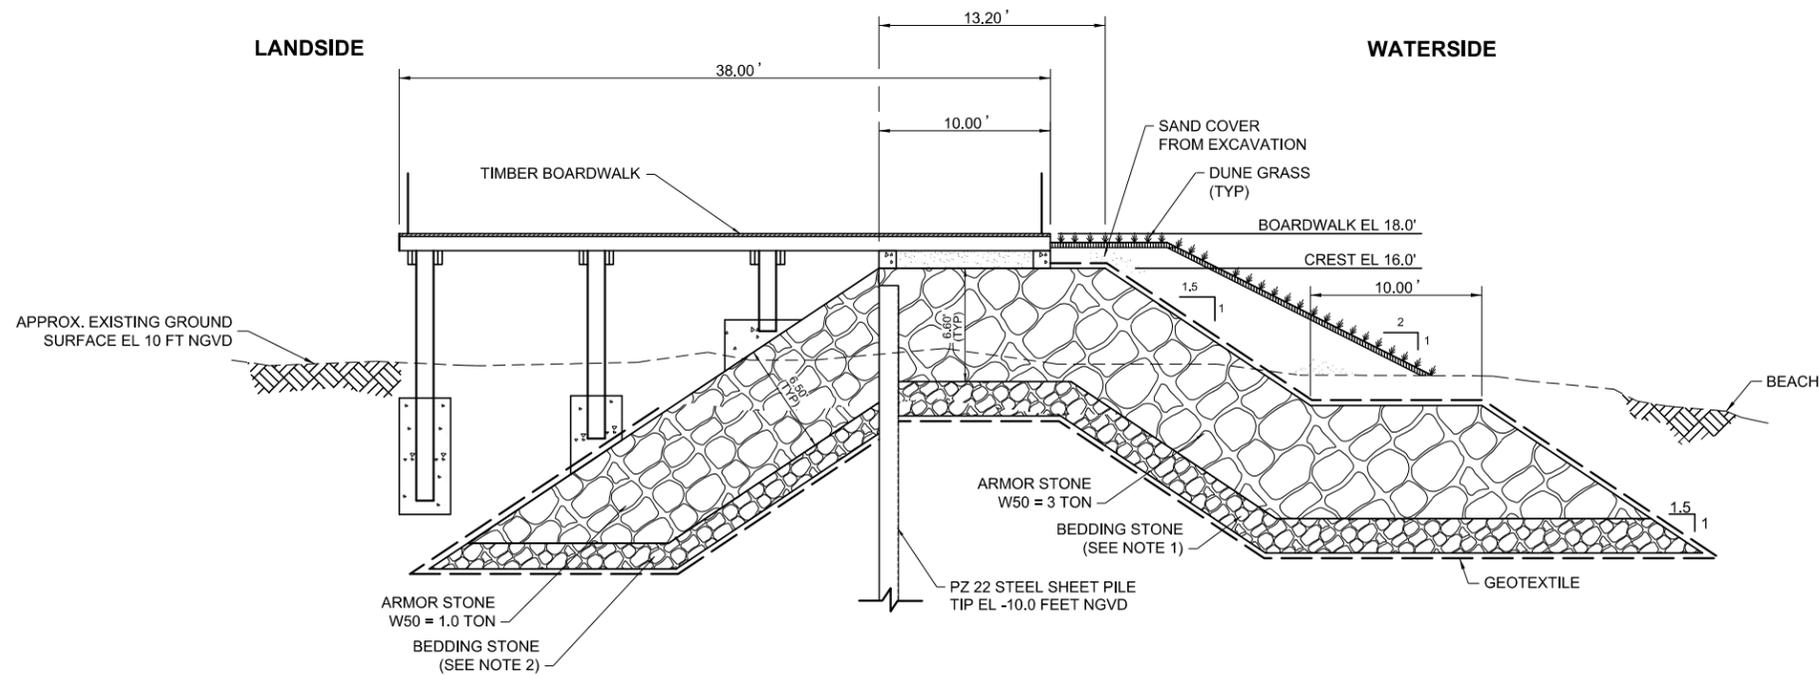
A2 BURIED SEAWALL SECTION (13.3 SWL)
 FORT WADSWORTH
 SCALE: 3/16"=1'-0"

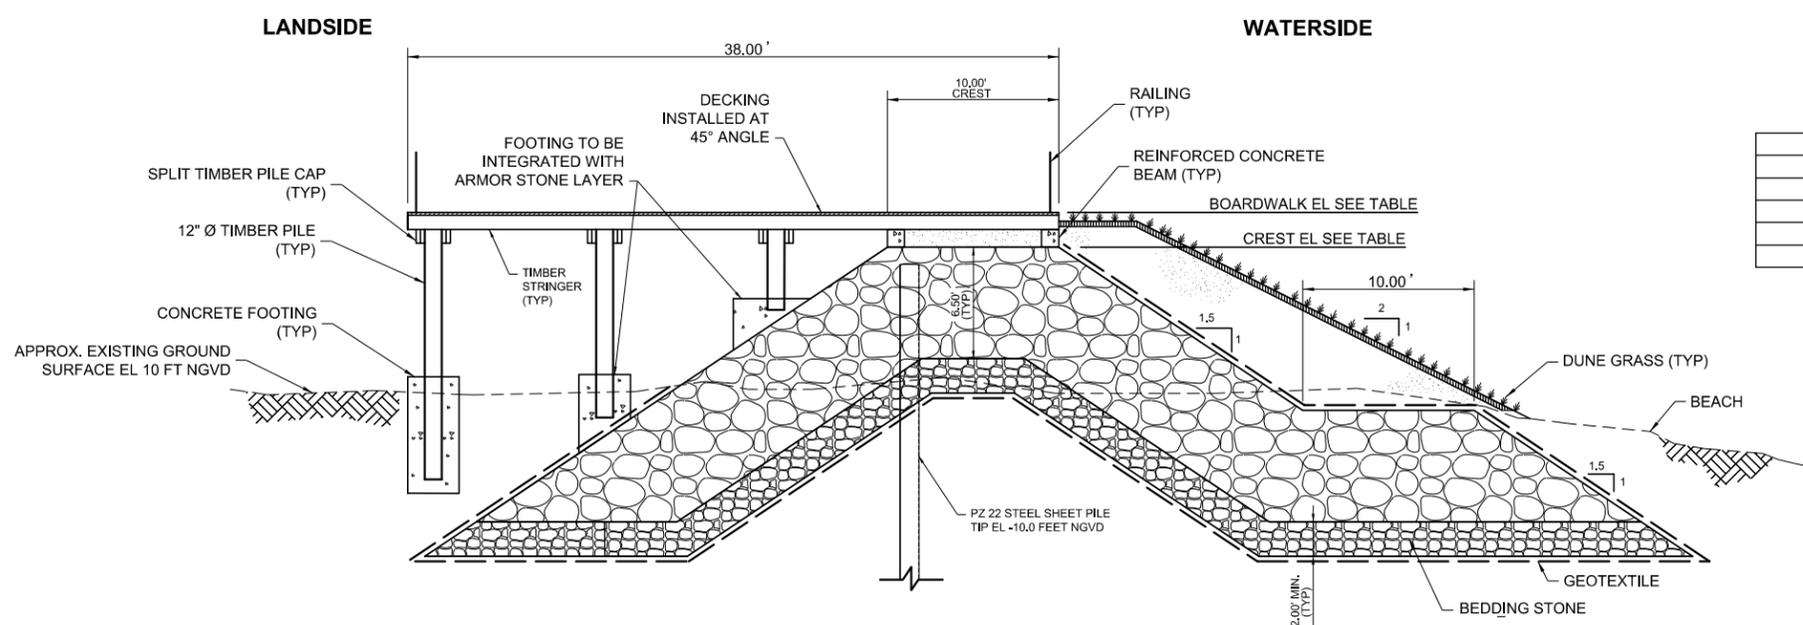
ELEVATIONS (FT, NGVD)		
SWL	CREST ELEVATION	TOP OF BOARDWALK
13.3	16.0	18.0
14.3	18.0	20.0
15.6	20.5	22.5
16.6	22.5	24.5

NOTE
1. SECTION REPRESENTS TYPICAL BOARDWALK SECTION FROM STA. 158+00 TO STA. 266+00.

B2 TYPICAL SECTION - BOARDWALK
C-507 SCALE: 3/16"=1'-0"

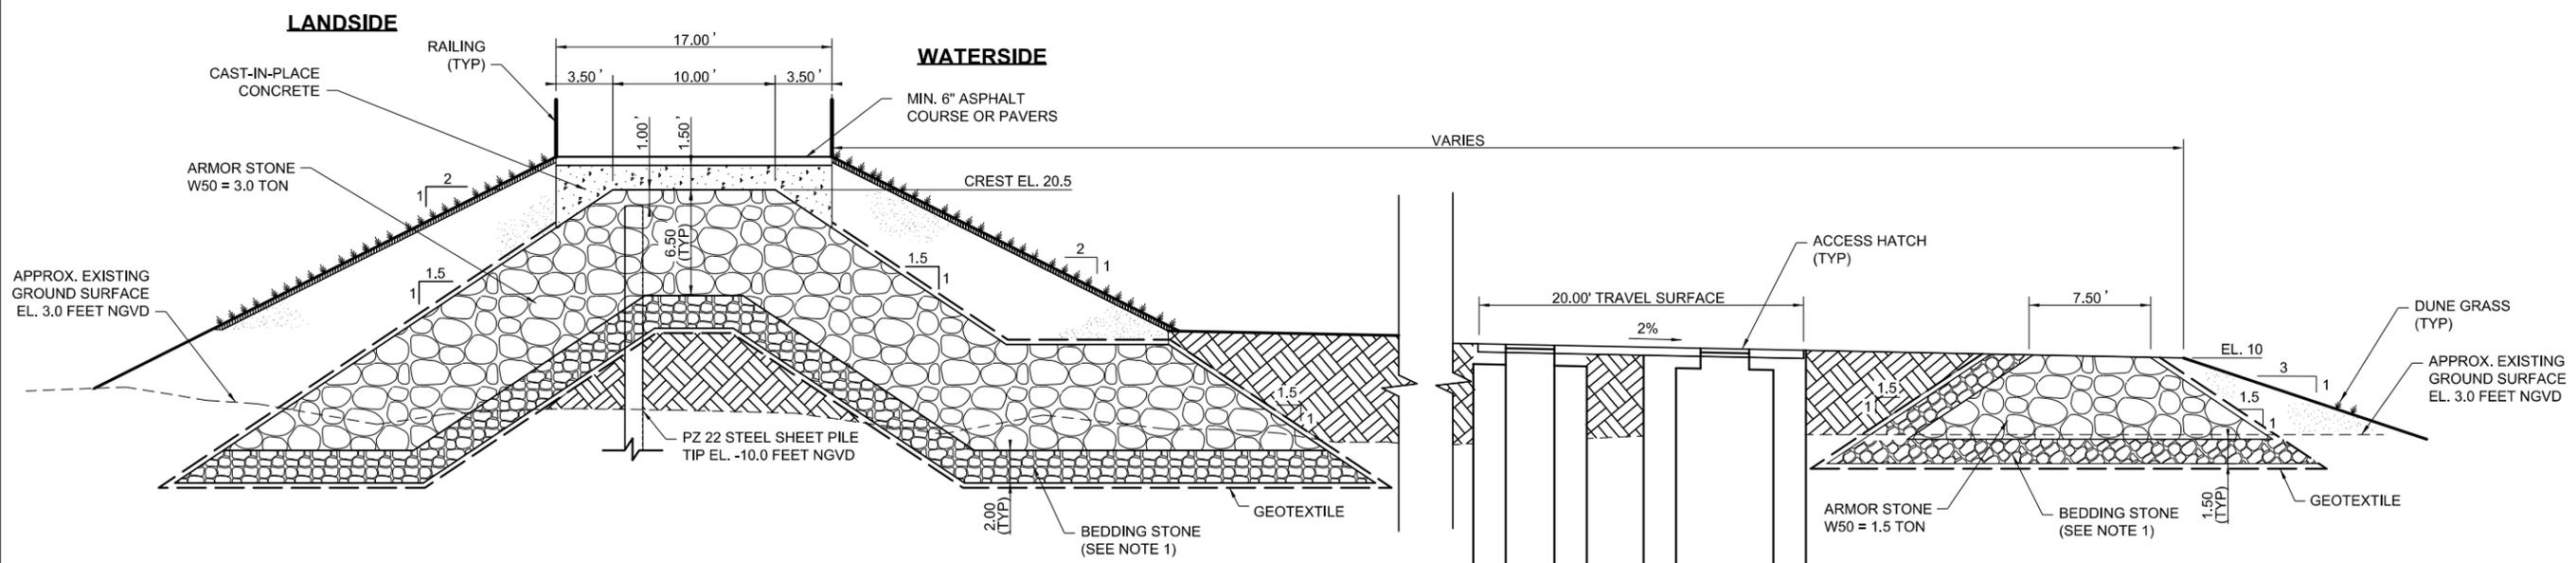
A2 TYPICAL SECTION - ROADWAY
C-507 SCALE: 3/16"=1'-0"

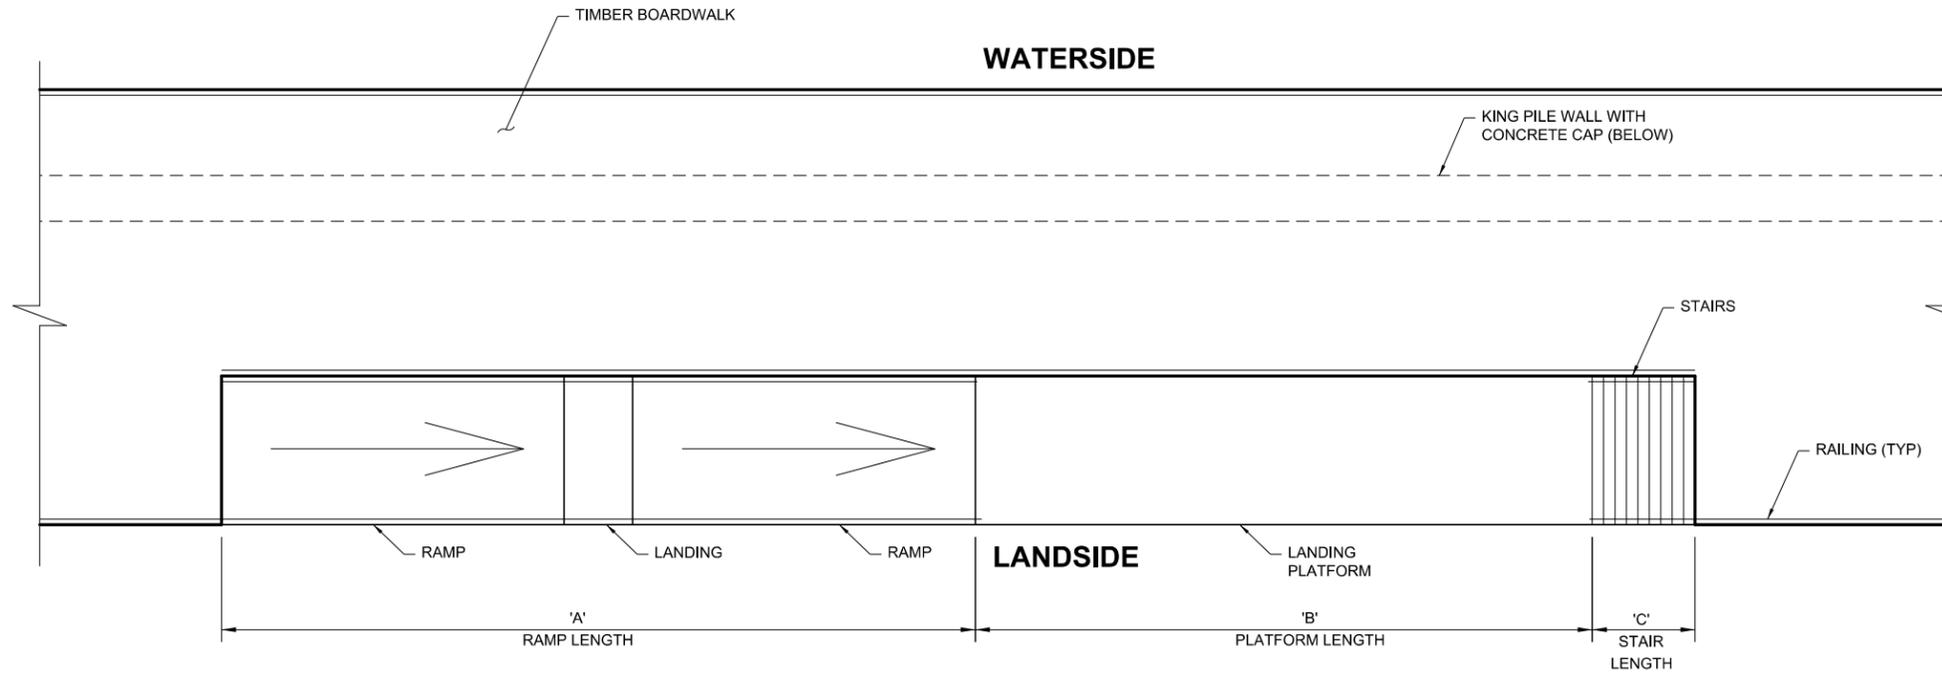
C1 TYPICAL PLAN - BOARDWALK ACCESS
C-508 SCALE: NTS

APPROX. BEGIN STATION	TOTAL LENGTH (FT)	PLATFORM ELEVATION (FT)	DIMENSIONS		
			RAMP 'A' (FT)	PLATFORM 'B' (FT)	STAIR 'C' (FT)
162+50'	265	ON GRADE	160	89	16.0
189+00'	495	ON GRADE	155	325	15.0
221+00'	230	17.0	66	156	8.0
262+50'	467	17.0	66	393	8.0

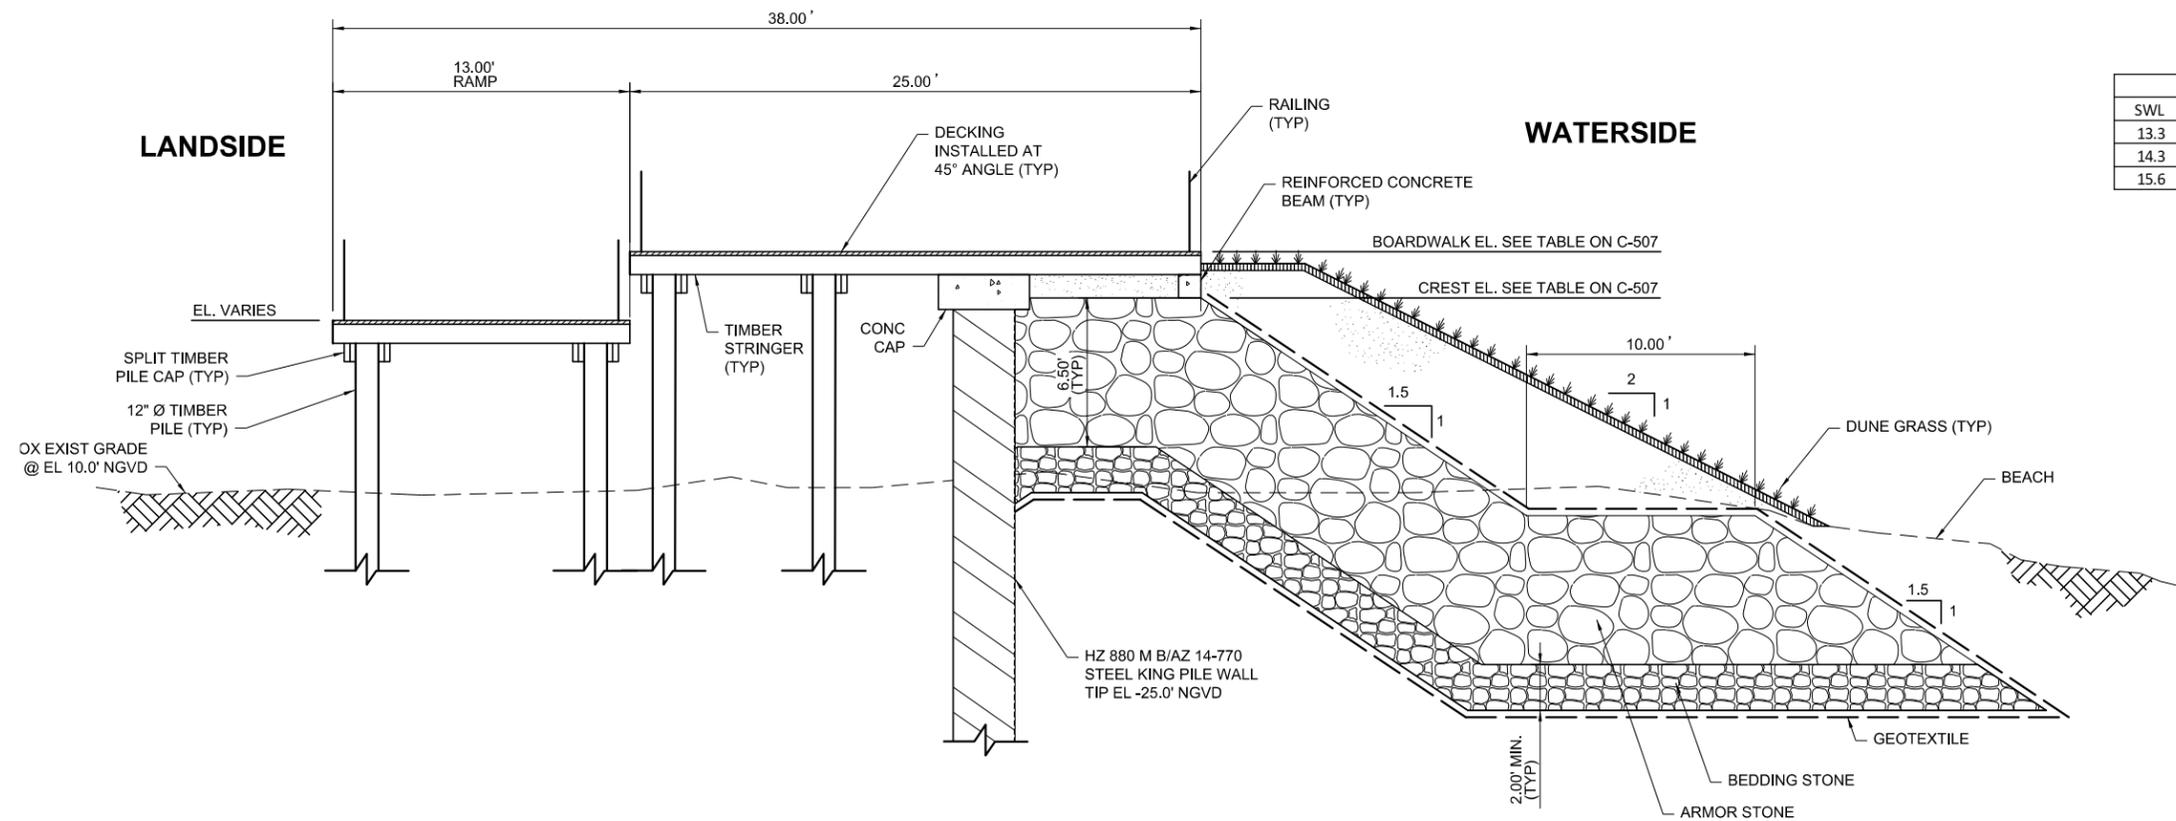
A1 TYPICAL SECTION - BOARDWALK ACCESS
C-508 SCALE: 1/4"=1'-0"

ELEVATIONS (FT, NGVD)		
SWL	CREST ELEVATION	TOP OF BOARDWALK
13.3	16.0	18.0
14.3	18.0	20.0
15.6	20.5	22.5
